**Lanesboro City Council
Special Meeting Agenda
Monday, September 15, 2025 at 11:30 a.m.
Lanesboro Community Center Meeting Room**

**RE: Lanesboro City Hall- Indoor Air Quality Assessment
IEA Project #202511088**

IEA, Inc. (IEA) is pleased to provide this report for the indoor air quality (IAQ) assessment of the City Hall in Lanesboro, Minnesota. The assessment was conducted on August 26, 2025, by IEA representative Justin Brown. The assessment included a visual inspection, spore-trap air, and tease-tape surface fungal sampling from within concern areas of the City Hall facility.

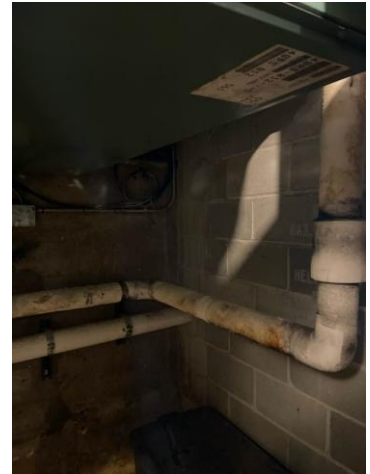
Discoloration confirmed by tape lift to be fungal growth was observed on the surface of the pipe insulation throughout the room. Presumed fungal growth was also observed on the surface of the ceiling, stored tables and chairs, and inside the air handling unit.

Cafeteria HVAC room:
discoloration on pipe.

- Remove the fungal-impacted pipe insulation under controlled conditions per IICRC S520 *Standard and Reference Guide for Professional Mold Remediation*.
 - Work should be performed by an experienced mold remediation contractor.

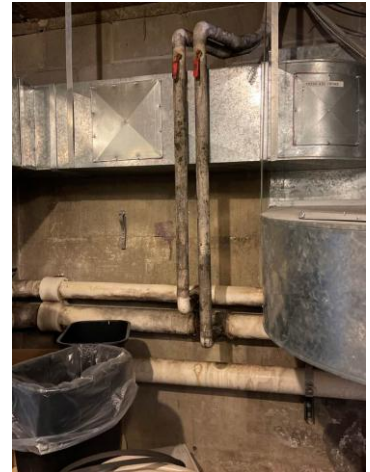
Cafeteria HVAC room:
discoloration on pipe

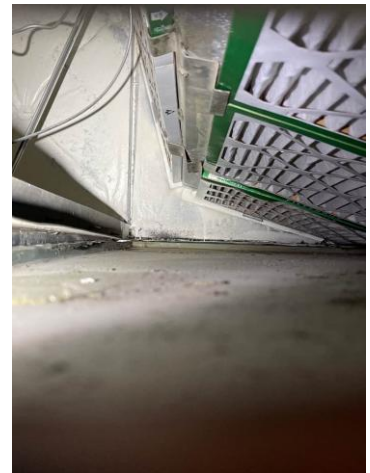
Dust accumulation was observed inside the air handling unit.

Cafeteria HVAC room: inside
unit dirty

- Clean all horizontal surfaces throughout the impacted areas by means of HEPA vacuuming and wet wiping.
- The air handling unit and associated ductwork should be fogged with an approved anti-microbial application. After the product recommended hold time, the surfaces should be HEPA vacuumed to remove any non-viable fungal spores that may be present. If the ductwork has interior insulation, IEA recommends cleaning and coating with an anti-microbial encapsulant. Work should be done by a professional mold remediation contractor. Filters should be changed following completion of the fog.

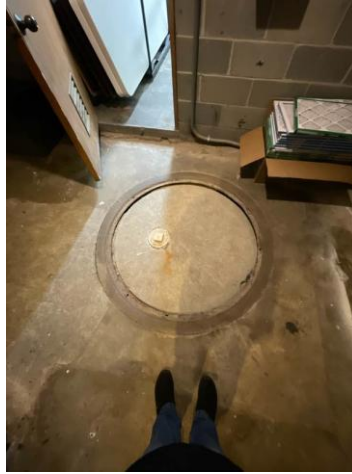
Cafeteria HVAC room. Old sewer line access hatch. Maintenance believes its bypassed but could still hold water leading to high humidity in room.

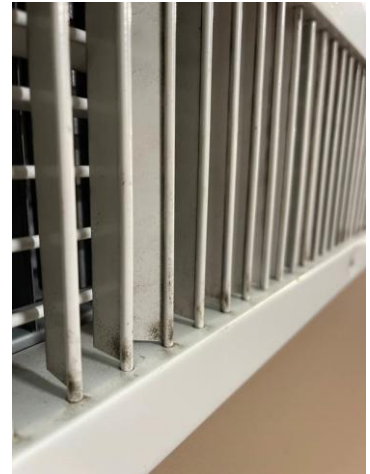
Discoloration, believed to be fungal growth, was observed on the air supply vents.

Cafeteria air supply grate discoloration

- Clean and sanitize the air supply vents under controlled conditions per IICRC S520 *Standard and Reference Guide for Professional Mold Remediation*.
 - Work should be performed by an experienced mold remediation contractor.
 - Clean all horizontal surfaces throughout the impacted areas by means of HEPA vacuuming and wet wiping.
- The carpet should be vacuumed on a regular basis using a HEPA-filtered vacuum cleaner to reduce dust and fungal loading.
- IEA should conduct a post-remediation verification as soon as remediation is complete, and surfaces have dried and prior to reconstruction.
- IEA recommends maintaining the relative humidity levels between 30% and 50%

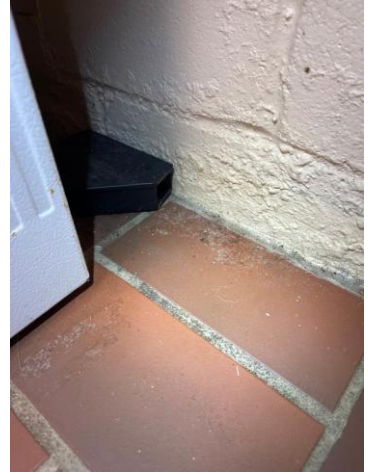
Discoloration confirmed by tape lift to be fungal growth was observed on the surface of the kitchen sink drain. Fungal growth was also observed on the east side of the kitchen on the walls, tile flooring, and water piping.

Kitchen. Efflorescence on block wall. Discoloration, assumed visible fungal growth

- Clean and sanitize the walls, flooring, and water piping in the east side of the kitchen under controlled conditions per IICRC S520 *Standard and Reference Guide for Professional Mold Remediation*.
 - Work should be performed by an experienced mold remediation contractor.
 - Clean all horizontal surfaces throughout the impacted areas by means of HEPA vacuuming and wet wiping.
- IEA should conduct a post-remediation verification as soon as remediation is complete, and surfaces have dried and prior to reconstruction.
- IEA recommends maintaining the relative humidity levels between 30% and 50%

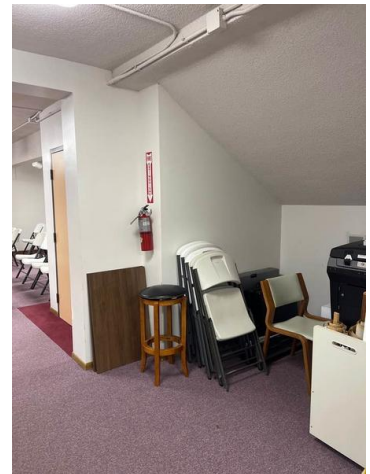
Meeting room. Very stagnant. Appeared to be no air flow in this area.

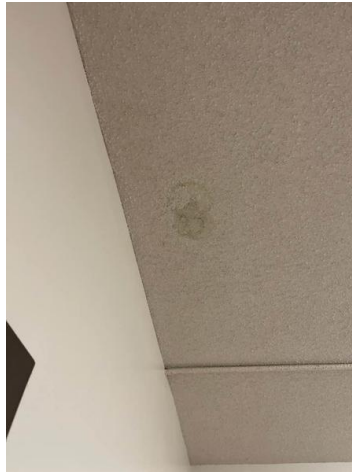
Water staining was observed on the ceiling surface.

Meeting room ceiling stained

- The water staining on the ceiling should be repaired.
- Clean and sanitize the return air duct.
- The carpet should be vacuumed on a regular basis using a HEPA-filtered vacuum cleaner to reduce dust and fungal loading.
- IEA recommends maintaining the relative humidity levels between 30% and 50%.

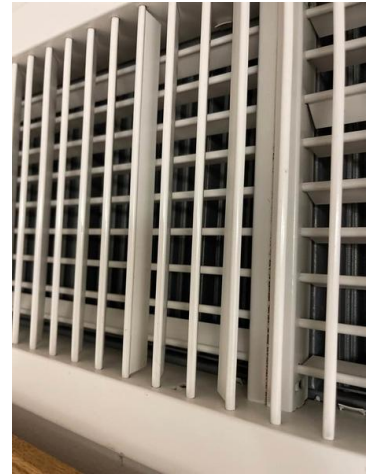
Meeting room supply.
Appeared to be no air flow

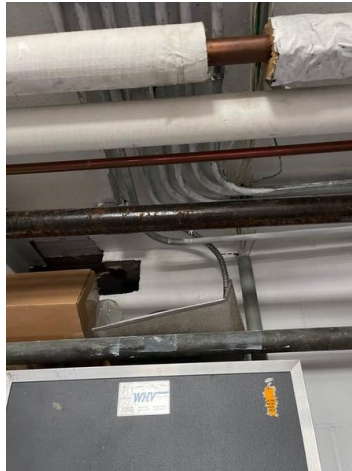
An uninsulated pipe was noted, and IEA was informed that it causes water to drip onto the floor.

Boiler room. Non insulated pipe. Maintenance noted on certain days this pipe just drips directly on to floor.

- Remove the fungal-impacted pipe insulation under controlled conditions per IICRC S520 *Standard and Reference Guide for Professional Mold Remediation*.
 - Work should be performed by an experienced mold remediation contractor.
 - Materials being impacted by remediation should be sampled for asbestos and lead prior to disturbance.
 - Clean all horizontal surfaces throughout the impacted areas by means of HEPA vacuuming and wet wiping.
- The pipe should be insulated to prevent additional dripping onto the floor.
- The garden hose should be cleaned and sanitized or disposed of.
- IEA should conduct a post-remediation verification as soon as remediation is complete, and surfaces have dried and prior to reconstruction.
- IEA recommends maintaining the relative humidity levels between 30% and 50%.

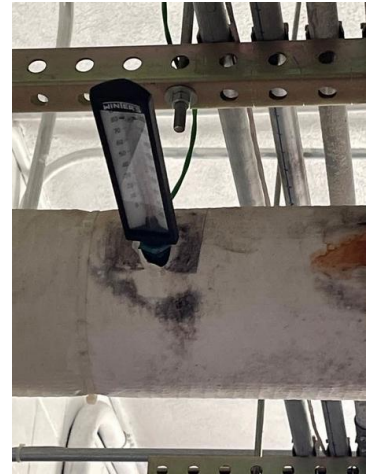
Discoloration was observed on the floor beneath the non-insulated pipe, on a garden hose, on the pipe supplying the library area, on the wall, and on other pipe insulation in the room.

Boiler room: discoloration on pipe insulation

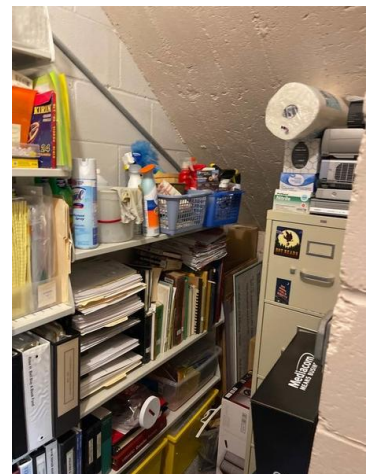
A damp mildew odor was noted in the small storage room.

Library small storage room.
Non vented door and no
HVAC in this area. Very damp
and mildew odor.

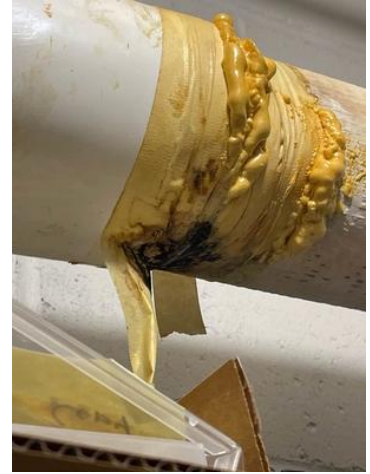
Discoloration was observed on the pipe insulation in the small storage room.

Library small storage room:
pipe discoloration

- Remove the fungal-impacted pipe insulation under controlled conditions per IICRC S520 *Standard and Reference Guide for Professional Mold Remediation*.
 - Work should be performed by an experienced mold remediation contractor.
 - Materials being impacted by remediation should be sampled for asbestos and lead prior to disturbance.
 - Structural components should be cleaned and sanitized prior to reconstruction.
 - Clean all horizontal surfaces throughout the impacted areas by means of HEPA vacuuming and wet wiping.
- The water staining on the ceiling outside of the small storage room should be repaired.
- IEA should conduct a post-remediation verification as soon as remediation is complete, and surfaces have dried and prior to reconstruction.
- IEA recommends maintaining the relative humidity levels between 30% and 50%.

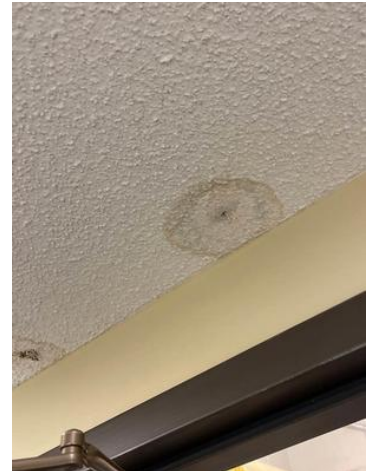
Water staining was observed on the ceiling outside of the small storage room.

Library: discoloration and
staining on ceiling outside of
the small storage room.

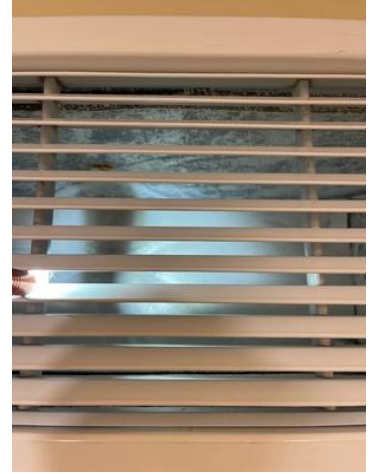
Library return air duct painted interior insulation. Discoloration may be present.

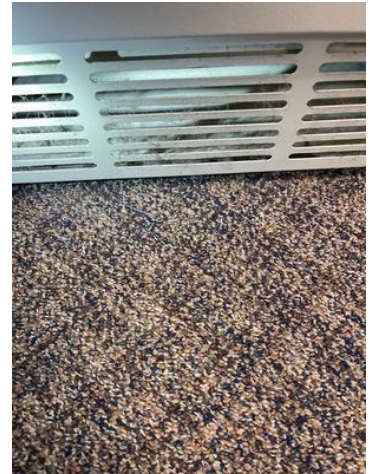
Dust accumulation was observed on the air supply and return vents throughout the area.

Office area Unit-vent intake at floor; dusty and dirty.

- Horizontal surfaces throughout should be cleaned by means of HEPA vacuuming and wet wiping.
- Clean and sanitize the air supply and return vents throughout the office area.
- Inspect the uninvent filter and ensure it is clean and replaced per the manufacturer's recommendations.
- The carpet should be vacuumed on a regular basis using a HEPA-filtered vacuum cleaner to reduce dust and fungal loading.

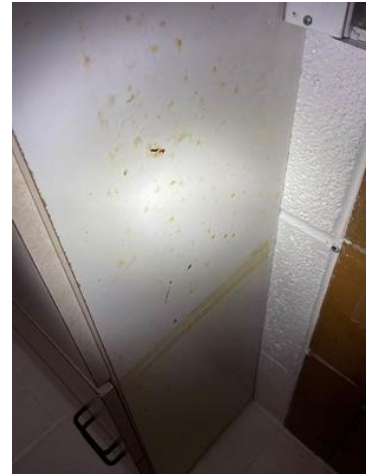
The concessions area appeared very dusty, and rusting was observed on the bottom of the metal cabinets.

Gymnasium concessions area. Bottom of metal cabinets rusting from excess moisture

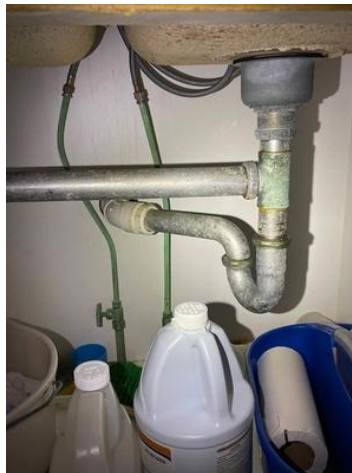
Discoloration was observed on the upper portion of the east and west walls, on the pipes beneath the sink in the concessions area, and on the grout in the showers of the lower shower room.

Gymnasium concessions under sink. Excessive moisture evident in the past. Growth on metal pipes

- Clean and sanitize the upper portion of the east and west walls, the pipes beneath the sink in the concessions area, and the showers under controlled conditions per IICRC S520 *Standard and Reference Guide for Professional Mold Remediation*.
 - Work should be performed by an experienced mold remediation contractor.
 - Clean all horizontal surfaces throughout the impacted areas by means of HEPA vacuuming and wet wiping.
- The gymnasium air supply and return vents should be cleaned and sanitized.
- IEA should conduct a post-remediation verification as soon as remediation is complete, and surfaces have dried.
- IEA recommends maintaining the relative humidity levels between 30% and 50%.

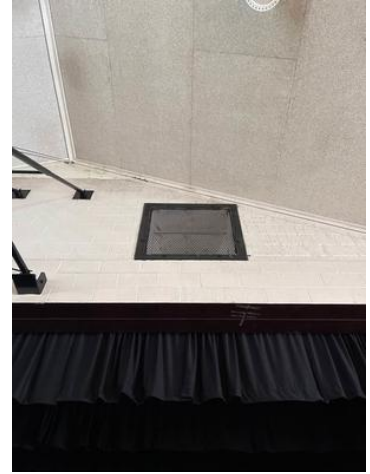
Dust accumulation was observed on the gymnasium air supply and return vents.

Gymnasium supply. Dusty and dirty
