**Lanesboro City Council
Special Meeting Agenda
Monday, September 15, 2025 at 11:30 a.m.
Lanesboro Community Center Meeting Room**

**RE: Lanesboro City Hall- Indoor Air Quality Assessment
IEA Project #202511088**

IEA, Inc. (IEA) is pleased to provide this report for the indoor air quality (IAQ) assessment of the City Hall in Lanesboro, Minnesota. The assessment was conducted on August 26, 2025, by IEA representative Justin Brown. The assessment included a visual inspection, spore-trap air, and tease-tape surface fungal sampling from within concern areas of the City Hall facility.

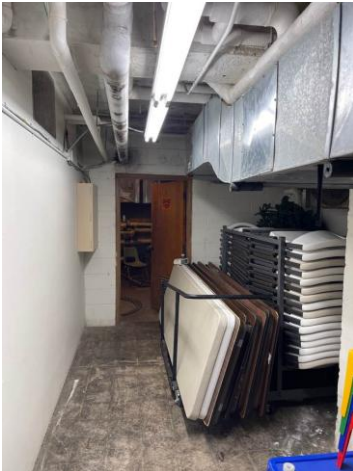
<p>Cafeteria HVAC room: discoloration on tables and stored materials.</p></div> <div>

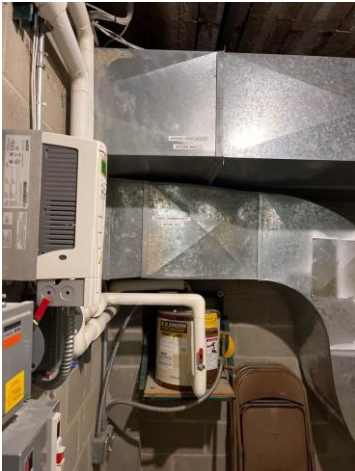
<p>Cafeteria HVAC room</p></div>

- The room consists of concrete ceiling, wallboard and block walls, and concrete floor.
- Discoloration, confirmed to be fungal growth, and water staining were observed on the surface of the pipe insulation throughout the room.
- Discoloration was observed on the ceiling.
- Stored tables and chairs were observed to have discoloration and dust accumulation.
- A label on the air handling unit indicated it was cleaned by Mavo Systems Inc. on July 7, 2021.
- Discoloration was observed inside the air handling unit, along with visible dust accumulation.
- An old sewer line access hatch was observed. An employee informed IEA that it is bypassed, but believes it may still retain water, potentially contributing to elevated humidity in the area.

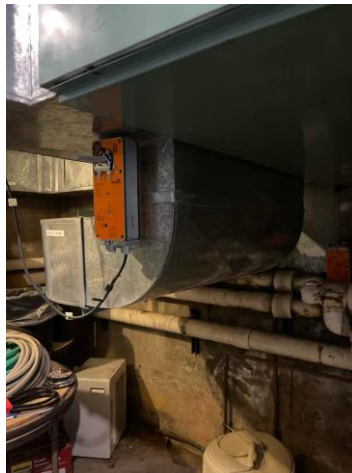
Cafeteria HVAC room:
discoloration

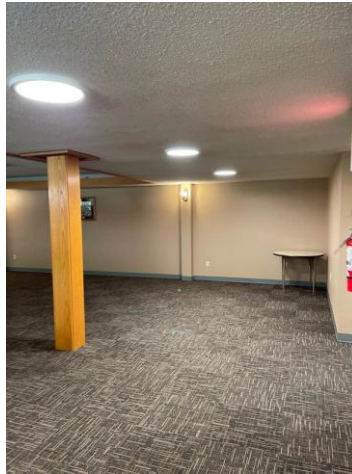
Cafeteria

- The room consists of plaster ceiling, wallboard walls, and carpet floor.
- Discoloration was observed on the air supply vents.

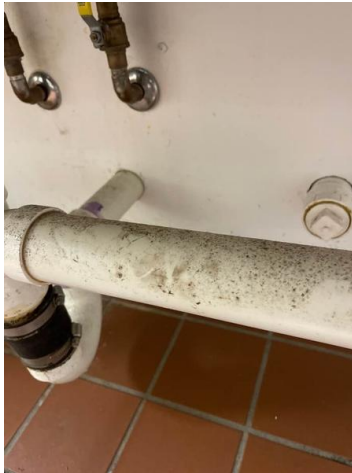
- The room consists of plaster ceiling, block walls, and tile floor.
- Discoloration was observed on the east side of the kitchen on the walls, tile flooring, and water piping. Through use of tease-tape lift, IEA confirmed the presence of fungal growth on the piping.

Kitchen. Discoloration, assumed visible fungal growth

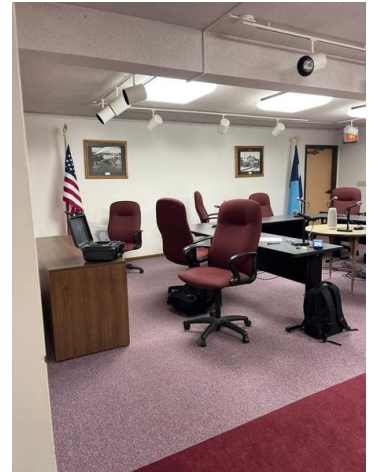
Meeting room

- The room consists of plaster ceiling, wallboard walls, and carpet floor.
- Water staining was observed on the surface of the ceiling.
- IEA observed that the air in the room was very stagnant, and there appeared to be no airflow at the supply.
- The return air duct appeared dusty.

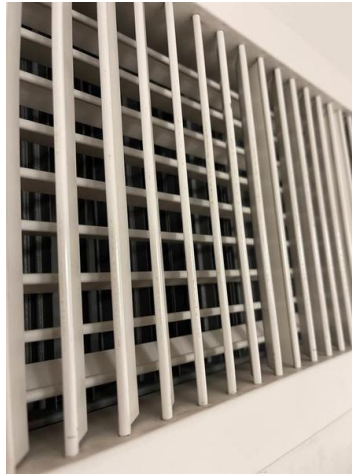
Meeting room supply.
Appeared to be no air flow

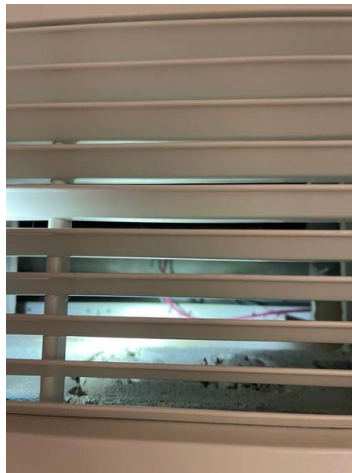
Meeting room return

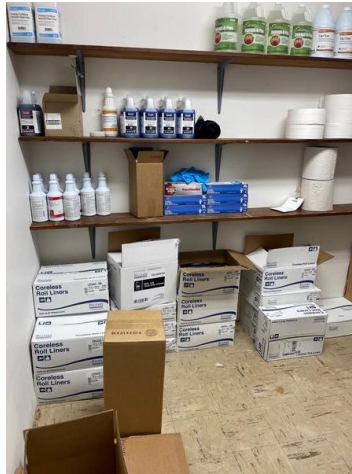
Meeting room storage.
Cardboard stacked tight
against wall and directly on
floor.

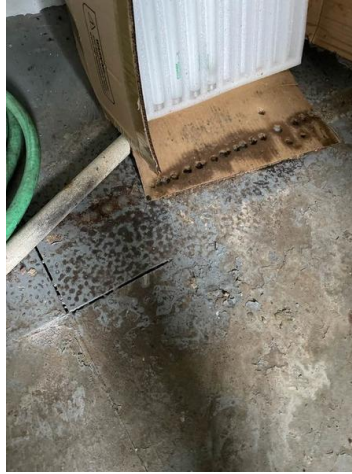
- The room consists of plaster ceiling, block walls, and concrete floor.
- A non-insulated pipe was observed. IEA was informed that it drips directly onto the floor.
- Discoloration was observed on the floor beneath the non-insulated pipe, on a garden hose, on the insulation on pipe supplying the library area, on the wall, and on other pipe insulation within the room.

Boiler room. Floor below non insulated pipe.

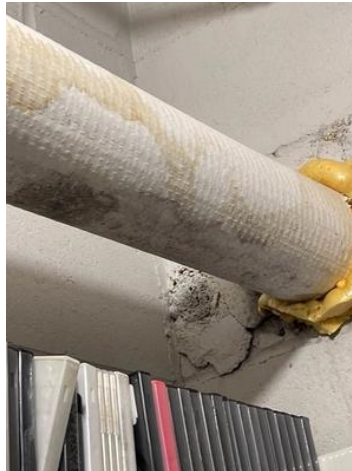
Library small storage room.
Discoloration at wall and on
pipe insulation.

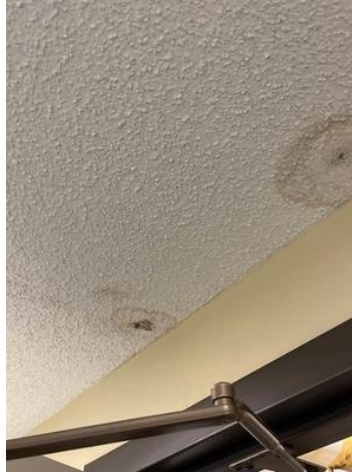
Library ceiling outside of the storage closet.

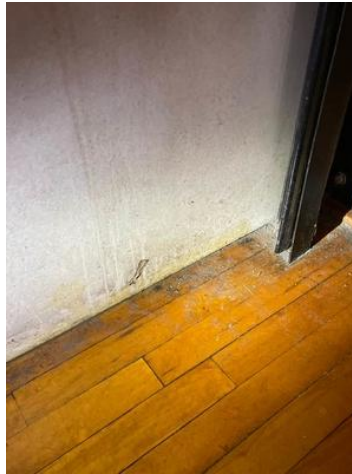
Gymnasium concessions area. Very dusty and dirty

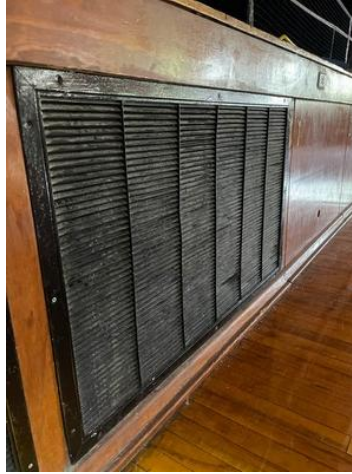
Gymnasium return. Dusty and dirty

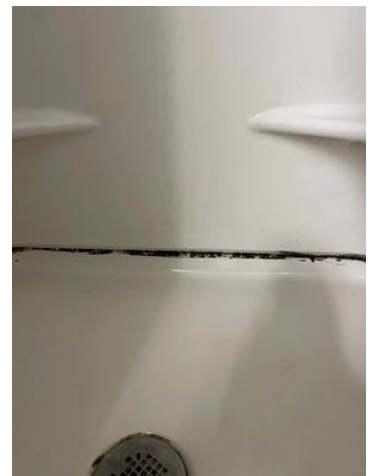
Showers in lower shower room.

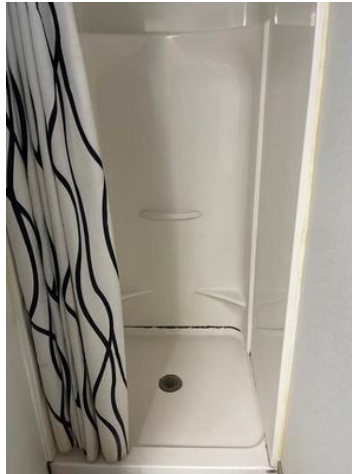
Showers in lower shower room. Discoloration on grout; assumed visible fungal growth

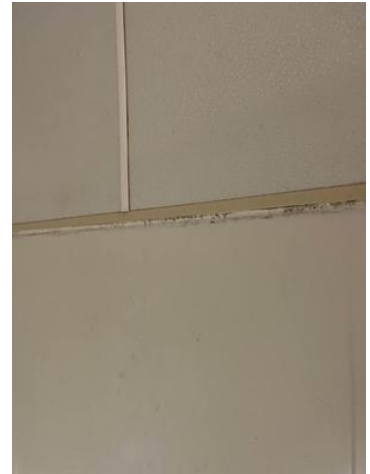
Showers in lower shower room.

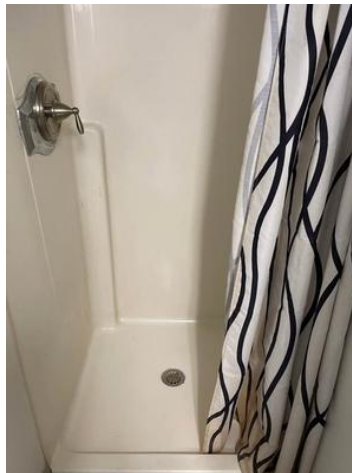
Showers in lower shower room.
